Audio	Quick Service Manual	Ref.No. : MESA0303PM17a
	Model : SA-PM17,PM27,PM47	Date : 31.March. 2004(Revised)
		Cases reported (country)
		Japan
Special customer inquiry <input type="checkbox"/>	Parts shortage solution <input type="checkbox"/>	Fregunce level
Improve by External factor <input type="checkbox"/>	Product improvement <input checked="" type="checkbox"/>	High <u>Low</u> A few One

Subject : CD Tray does not open/Close (CR16 Mechanism)

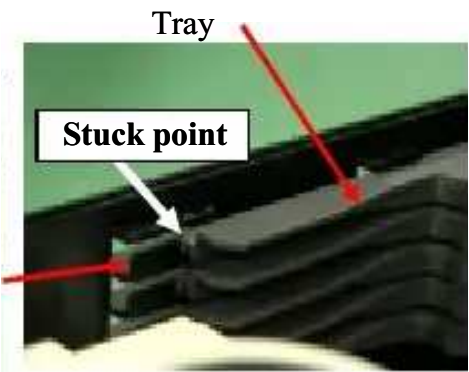
Symptom : Tray does not open/Close, Tray stuck

Cause : 1) Misalignment of mechanism.
2) Shift UD SPEED DOWN GEAR by abnormal use.
when Tray was jammed with Mechanism chassis Ribs
3) No complete initialization at power off mode.
